Subject: Geotechnical Investigation  
Big Creek Road Washout  
Plumas County, California

GEOTECHNICAL INVESTIGATION

Big Creek Road Washout  
Plumas County, California

**GEOTECHNICAL INVESTIGATION**Big Creek Road Washout  
Plumas County, California

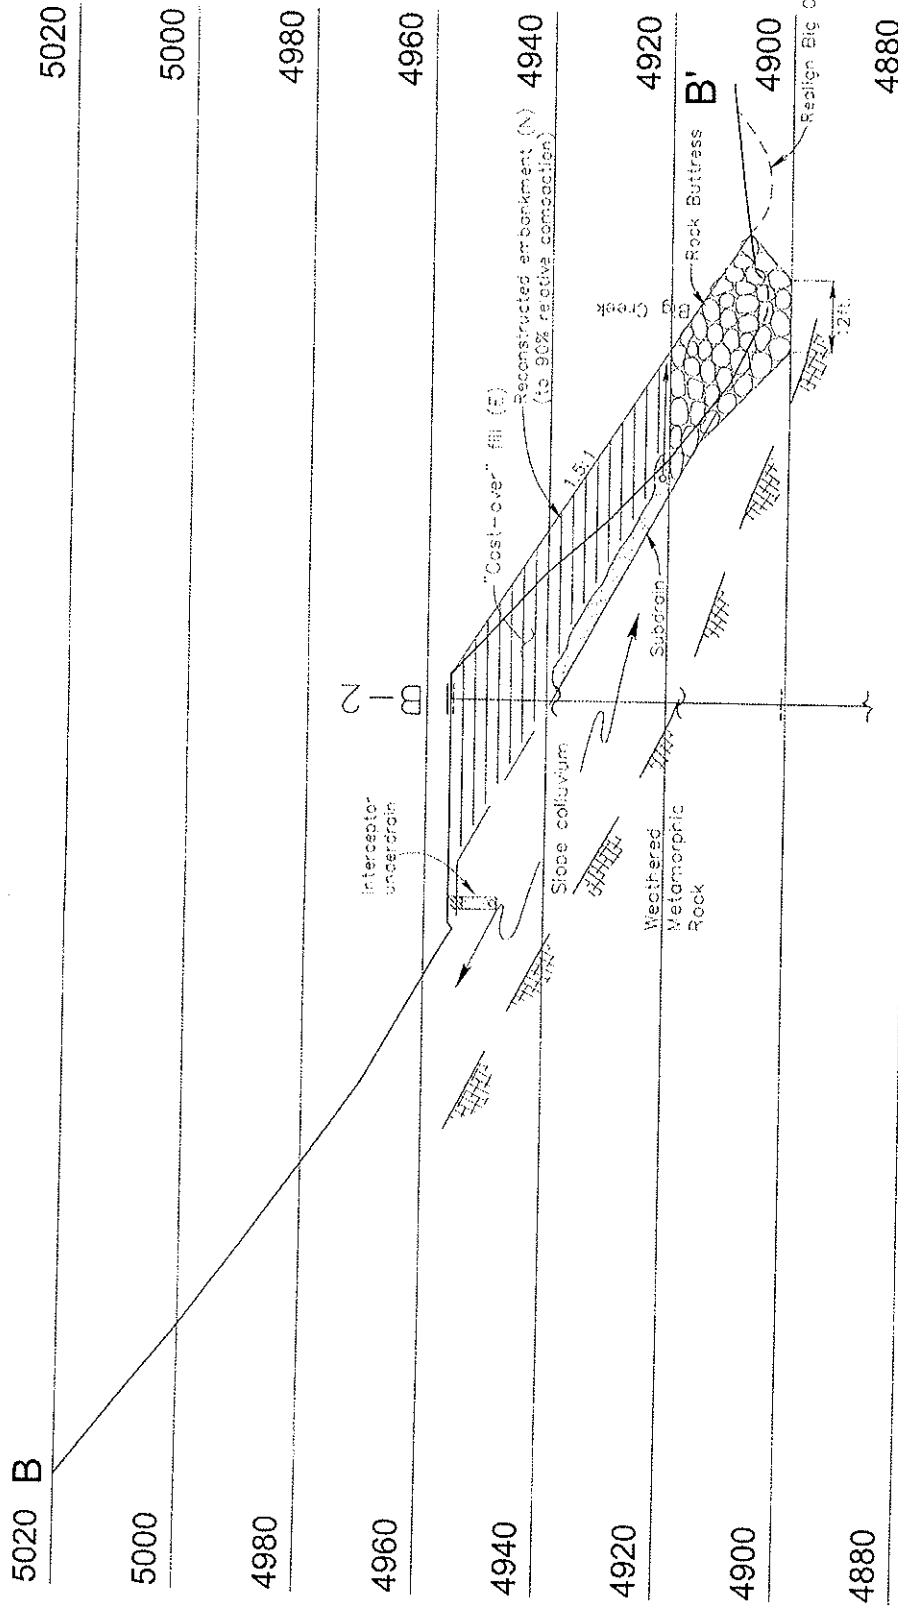
Option-2: Reconstructed Embankment  
Section B-B', Sta. 276+75

On the basis of the foregoing, it is concluded that the subject bank failure occurred primarily within the unconsolidated (largely "cast-over") upper-unit fill as a result of bank undercutting along the base of slope. The bank undercutting is especially severe at this location during periods of high water due to the adverse impact angle of Big Creek. Other factors contributing to slope instability include surface water infiltration; over-side sheet flow during storms and snowmelt runoff; and storm-induced seepage pressures developed within the unconsolidated upper and middle-unit materials. Without remedial work, renewal and extension of movement (both lateral and headward)--with additional roadway involvement--could be expected during future wet seasons.

to above high water level), and replacement of the embankment as a drained, engineered fill section. A  $20\pm$ ft shift of the creek away from the bank would be required to "fit" a rock buttress without modifying the road alignment or a typical  $1\frac{1}{2}$ :1 exterior slope. A sketch of this option is shown on Drawing-3.

A minimum 12-ft wide toe bench established about  $4\pm$ ft below channel bottom (into affirmed intact material) is expected to be appropriate for the buttress section. Construction is anticipated at times of low creek flow (i.e., late summer) and excavation inflow is expected to be controllable by pumping/diversion. The exposed base and backslope should be reviewed by a representative of this office to affirm anticipated materials and conditions.

A continuous subdrainage "blanket" consisting of a  $2\pm$ ft thick section of Permeable Materials (per Section 68, Caltrans Standard Specifications) should be placed along the backslope. Filter fabric is recommended around the drain materials to prevent mobilization of fines into the drain system. A perforated drain outlet should be placed near the top of the rock buttress with solid pipe outlet to the creek. Native fill materials (less any debris) are considered suitable for use as compacted embankment, placed to at least 90% relative compaction (per CTM 216).

To control and new embankment, An interceptor underdrain is recommended to extend to depth 6-8 ft along the inner road area to exclude shallow (seasonal) groundwater infiltration/seepage from road subgrade. A 2-ft wide drain consisting of Permeable Materials wrapped in filter fabric is considered appropriate with gravity relief north of the slide area. The surficial  $2\pm$ ft of the underdrain should be "capped" with native clayey soil to inhibit surface infiltration into the drain. The roadway should have an outer berm and overside drain to control surface runoff.
